# Post-Occupancy Evaluation Study of an Educational Building in Mexico:

## Occupant's perception vs. occupancy survey

This paper presents the results of a POE assessment of an educational building located in the city of Puebla in Mexico. The building is called La Monja Cultural Centre and is part of the Architecture Faculty of the University of Puebla (BUAP). La Monja is covered by four concrete shells joined by a central translucent dome. This building is an iconic university structure not only for the Faculty of Architecture but also for the whole university campus. It is a place where activities such as lectures, seminars and exhibitions take place. There are also some offices, a computer room and cafe on the ground floor. Due to the shape of the roof the building is commonly known as 'la Monja' or the 'Nun building' (Fig. 1). La Monja was built in 1969 and designed by architects Miguel Pavón Rivero and Jorge Belches Landero. Even though the

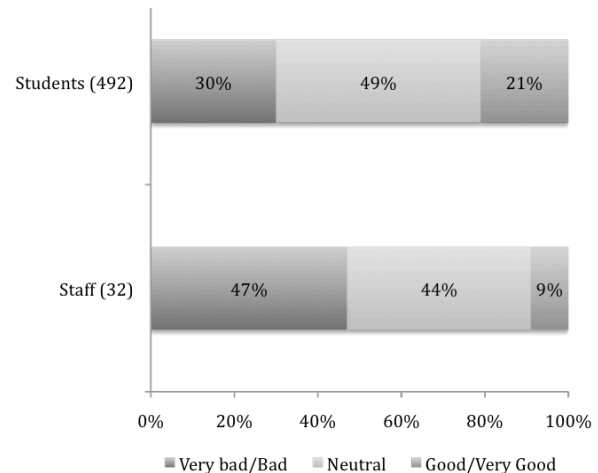
Figure 3: Users perception of the interior environment (source: 3).

Occupants were asked to give their impressions regarding the interior environment of the building. Most students think it is neutral or bad, while most staff respondents were more critical saying that the environment of La Monja is bad and very bad (Fig. 3) [3]. One third of the staff stated that the quality of daylight is bad/very bad for the activities they perform in the building. On the other hand, users believe the acoustics of the building is not too bad while others believe it is good/very good. Most of them think the shape of the concrete shells contribute to the quality of the acoustics of La Monja, particularly in the seminar rooms which are located underneath the concrete shells.

Finally, thermal control (temperature) and ventilation are the environmental aspects that were rated by most staff and students as being very bad and bad.

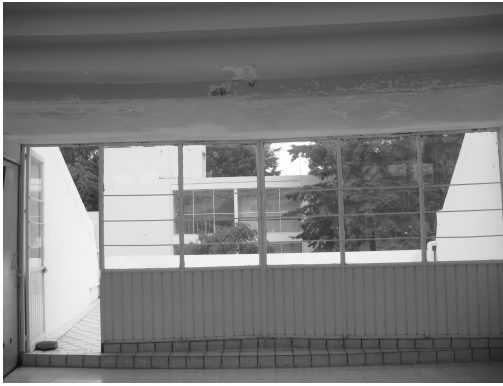
The least utilized areas according to this study are the three terraces located on the first floor (Fig. 4, 5), with only 1% occupancy. These terraces lack of proper exterior furniture, are not integrated into the main hall and corridor of that floor and the main problem is that the doors that communicate the hall with the terraces are most of the time locked. This problem was also raised by the focus group and through the questionnaire, where people pointed out this as one of the reasons of having bad ventilation on that floor.

Figure 4: Interior view of the door and windows that communicate to one of the terraces.

- 4) Give users control over their environment.
- 5) Green roof for thermal control.
- 6) Use of terraces for cross ventilation and stack effect through central dome.

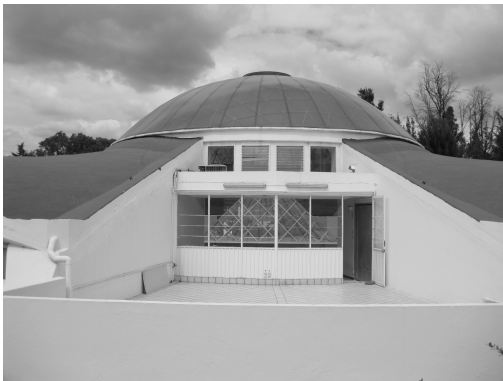
Figure 5: Exterior view of one terrace, 1<sup>st</sup> floor La Monja building.

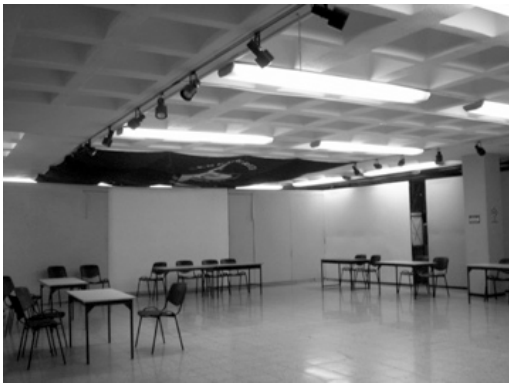
However, some people reported bad acoustics on the multiple use area on the ground floor, regardless of the cork panels; particularly when it is divided into smaller rooms and all are used at the same time.

Moreover, the multipurpose area located on the ground floor (Fig. 6) is also under-utilized with only 2% of its capacity. Originally, all the ground floor was a big open plan area for exhibitions. Currently, the floor has been divided to host the cafeteria, office space, storage space and one computer room. A central area with access through the main entrance of La Monja is considered to be a "flexible" space where special events take place, students work exhibitions, seminars and workshops. Furniture can be arranged to suit the event. However, there seems to be too few activities taking place in this area, or the activities that are held there are performed by only a few people. Hence, the space is not utilized to its full capacity.

Figure 6: Multipurpose room with movable partitions (ground floor).

- 5) Rearrangement of areas going back to its original open plan area on the ground floor but considering the use of: natural light, natural ventilation and outside views.
- 6) Passive solutions and the use of technology such as Photovoltaic panels to reduce the energy consumption of the building;
- 7) Organisational change to increase the use of the building;
- 8) Improve the relationship between La Monja and other faculty buildings, and inside La Monja between entrance halls, corridors, terraces, etc.
- 9) Landscape design.
